Overview

Symptom: No video signal from the OE Ford back up camera after installing the PAC CAM-FD21, or RPK4-FD2201.

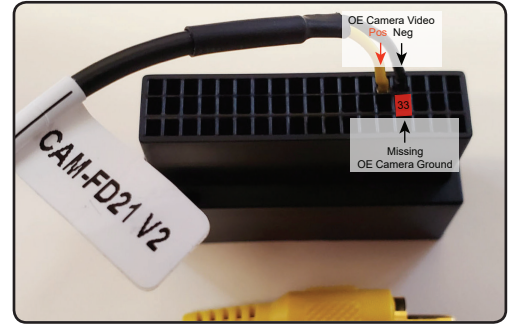
Cause: A ground wire is required for the OE camera in select vehicles equipped with SYNC.

Solution: Add a ground wire to the CAM-FD21 harness, or connect ground to the OE wire on the corresponding pin location in the OE harness.

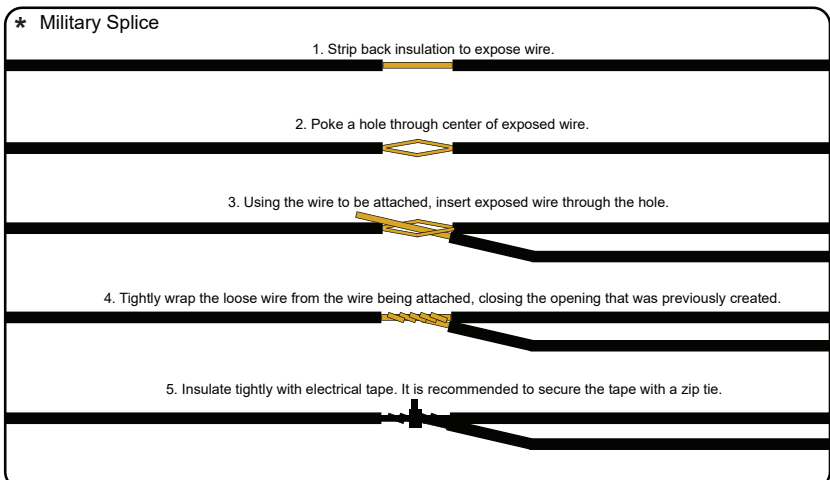
- Slide the connector out of the housing (Fig. 1b).
- Looking at the wire side of the 54-pin radio harness, locate the wire coming from pin 33 (typically a Black wire). This is the wire that requires a ground to allow the reverse camera to operate. Also locate pin 37 (typically Black / Gray). This is a wire that can be used to supply ground to pin 33 (Fig. 2).

- Solder or military splice* a small piece of scrap wire (18 gauge or larger) to pin 37, and the other end to pin 33, and insulate the connections with electrical tape.
